LAKE CLASSIFICATION SHORT REPORT SHERWOOD LAKE, ADAMS COUNTY, WI

**Presented by Reesa Evans, Lake Specialist
Adams County Land & Water Conservation Department
P.O. Box 287, Friendship, WI 53934**

AUGUST 2007

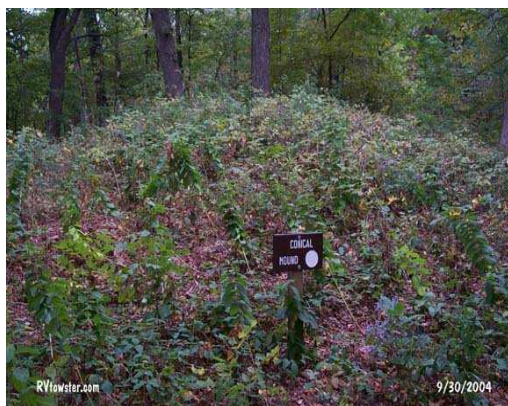
Conical mound

There are many Native American archeological sites in Adams County, with several being located right around in the Tri-Lakes watersheds. These mounds can be conical, linear or effigy (animal shapes) shapes. In order to preserve Native American heritage, federal and state laws on Native American burials require permission of the federal government and input from the local tribes before further disturbance.

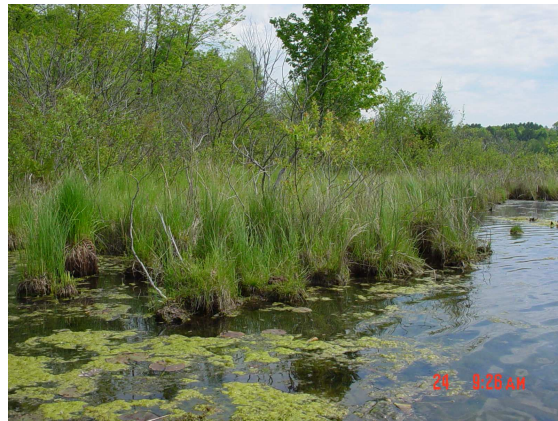
Example of a Lake Shore Wetland

There are several wetlands located in the Tri-Lakes watersheds. Wetlands play an important role in water quality by trapping many pollutants in runoff waters and by serving as buffers to catch and control what would otherwise be uncontrolled water and pollutants. Wetlands also play an essential role in the aquatic food chain, thus affecting fishery, and also serve as spaces for wildlife habitat, wildlife reproduction & nesting, and wildlife food.

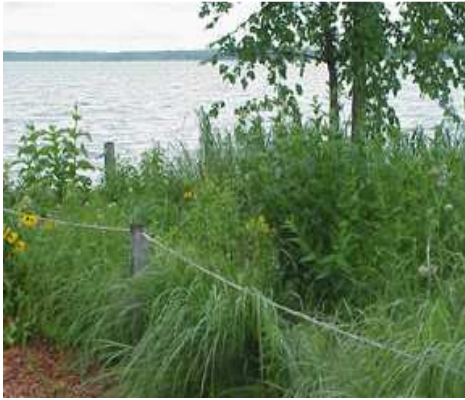
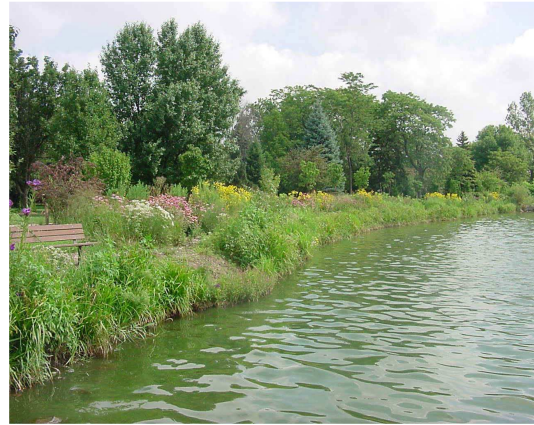
Examples of Adequate Buffers

A 2004 shore survey showed that very little of Sherwood Lake's shore had an "adequate buffer." An "adequate buffer" is a native vegetation strip at least 35 feet landward from the shore. Most of the "inadequate" buffer areas were those with rock or seawall, hard structures, beach, active erosion or mowed laws. In a few instances, those with insufficient native vegetation at the shoreline to cover 35 feet landward from the water line were also called "inadequate."

Shoreland buffers are an important part of lake protection and restoration. These buffers are simply a wide border of native plants, grasses, shrubs and trees that filter and trap soil & similar sediments, fertilizer, grass clippings, stormwater runoff and other potential pollutants, keeping them out of the lake. A 1990 study by the Wisconsin Department of Natural Resources of Wisconsin shorelines revealed that a buffer of native vegetation traps 5 to 18 times more volume of potential pollutants than does a developed, traditional lawn or hard-armored shore. The filtering process and bank stabilization that buffers provide help improve a lake's water quality, including water clarity.

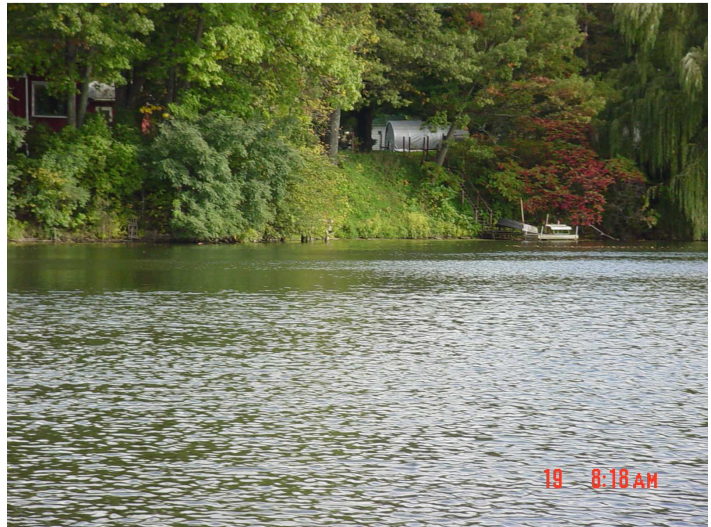
Example of Adequate Buffer

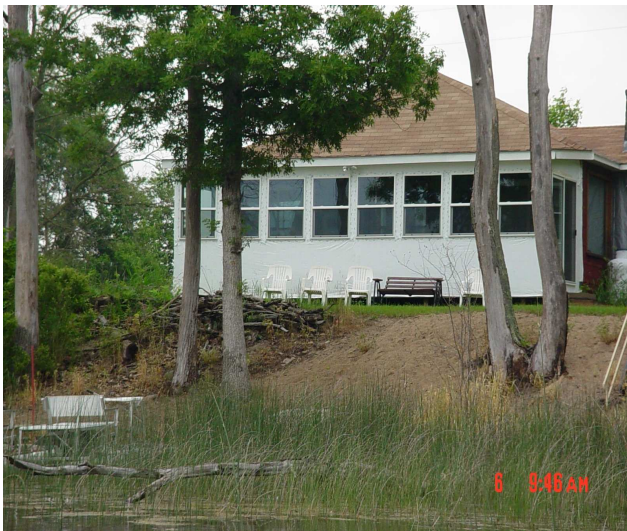
Example of Inadequate Buffer

Vegetated shoreland buffers help stabilize shoreline banks, thus reducing bank erosion. The plant roots give structure to the bank and also increase water infiltration and decrease runoff. A vegetated shore is especially important when shores are steep and sandy, as are many of the Sherwood Lake shores.

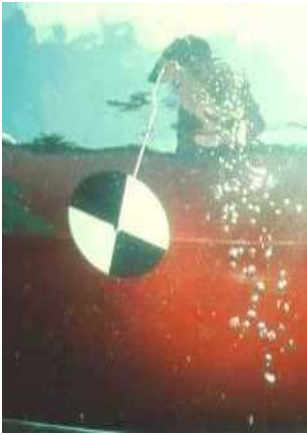
Water clarity readings are usually taken by using a Secchi disk (shown at right). **Average summer Secchi disk clarity in Sherwood Lake in 2004-2006 was 4.36 feet.** This places Sherwood Lake's water clarity in the "poor" to "fair" category. In the 1980s, water clarity averaged 5.4'; in the 1990s, the average was 5.6'. The current average is over a foot lower than those numbers. Water clarity can be reduced by turbidity (suspended materials such as algae and silt), frequent disturbance from shoreland development and boat traffic, and dissolved organic chemicals that color or cloud the water.

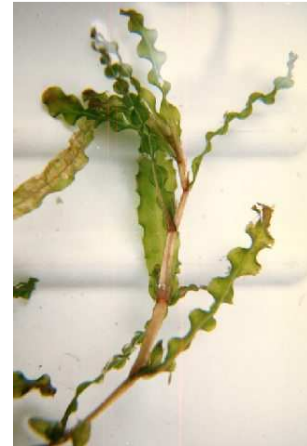
Curly-Leaf Pondweed

Important to maintaining a diverse aquatic plant community is an integrated aquatic plant management plan that controls the invasive plants in the lake. The most prevalent invasive exotic in Sherwood Lake is currently Curly-Leaf Pondweed. However, *Myriophyllum spicatum* (Eurasian watermilfoil), another aggressive invasive, was also found in the lake in 2006. *Lythrum salicaria* (Purple Loosestrife), an invasive shore plant, has also been found on Sherwood's shores. During the 2006 plant survey, a new invasive, *Nasturtium microphyllum* (watercress) was found in the lake in the 0-1.5' depth zone.

- The Tri-Lakes Management District should maintain exotic species signs at the boat landings and contact DNR if the signs are missing or damaged.
- The Tri-Lakes Management District should continue monitoring and control of Eurasian Watermilfoil and Curly-Leaf Pondweed, maintaining the most effective methods and modifying if necessary. The Sherwood Property Owners Association should assist in these efforts. Residents may need to hand-pull scattered plants.
